**Federal Aviation  
Administration**

# Preliminary Summary of the FAA's Review of the Boeing 737 MAX

Return to Service of the Boeing 737 MAX Aircraft

August 3, 2020

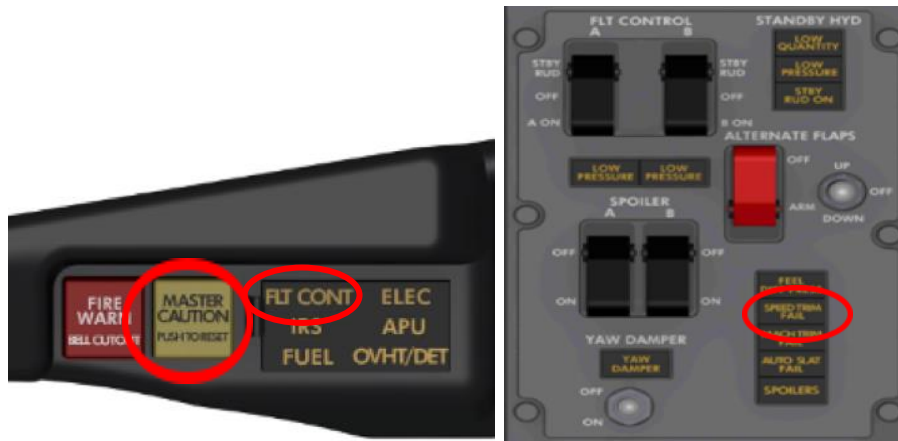
FIGURE 2 SPEED TRIM FAIL ANNUNCIATION

- Effect of Erroneous AOA Value on MCAS — If the valid AOA value differs from the other valid AOA sensor value by more than 5.5 degrees for a specified duration the AOA values are considered erroneous, the split vane monitor will detect the failure and both the MCAS and Speed Trim functions will be disabled for the remainder of the flight. A complete failure of the STS (which includes both MCAS and Speed Trim), will trigger a Master Caution indication, an illumination of the FLT CONT annunciator, and an illumination of the SPEED TRIM FAIL light on the overhead panel. The Master Caution indication and the FLT CONT annunciator can be reset by pressing the MASTER CAUTION PUSH TO RESET button. The SPEED TRIM FAIL light will remain illuminated for the remainder of the flight. In addition, an accompanying

maintenance item is recorded for the loss of MCAS and Speed Trim. The SPEED TRIM FAIL annunciation is shown in Figure 2.

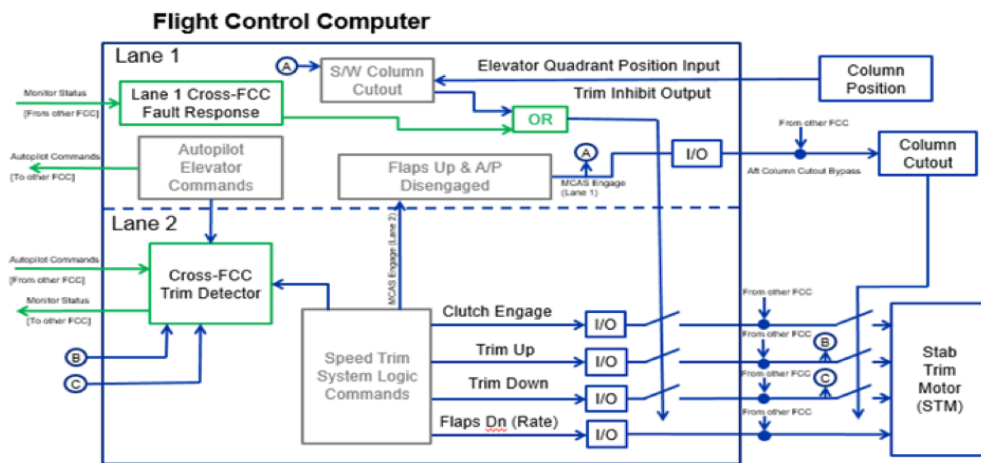
FIGURE 3 SIMPLIFIED SCHEMATIC OF THE UPDATED FCC SOFTWARE

The Cross-FCC Trim Monitor is a new feature to address Safety Item #6: OTHER POSSIBLE FCC STABILIZER RUNAWAY FAILURES and provides additional protection against erroneous FCC trim commands caused by postulated failures in the FCC Lane 2 CPU or I/O chips. This monitor is implemented in Lane 2 of the FCC.

A simplified schematic of the Cross-FCC Trim Monitor added in the updated FCC software is shown in Figure 3 below.

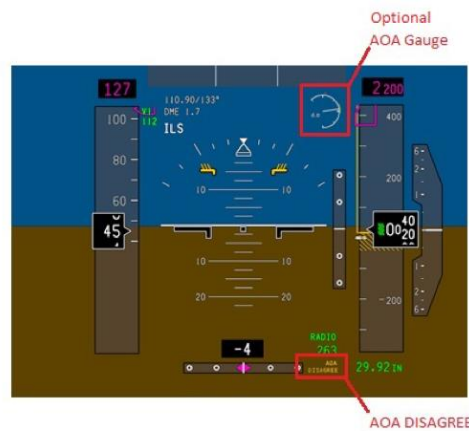
FIGURE 4 737 MAX MDS PFD WITH AOA DISAGREE AND AOA GAUGE

The 737 MAX MDS software change updates the AOA DISAGREE annunciation logic and addresses Safety Item #5: AOA DISAGREE. The AOA DISAGREE annunciation is displayed on the captain’s and first officer’s PFD when the left and right AOA values differ by more than 10 degrees for longer than 10 continuous seconds. An optional AOA gauge displays the AOA value on the captain’s and first officer’s PFD when the option is enabled. The AOA DISAGREE annunciation and AOA gauge are illustrated in Figure 4.

- Associated the AOA DISAGREE annunciation with the AOA gauge option, such that the AOA DISAGREE annunciation functioned only when the AOA gauge option was enabled.
- Displayed the AOA DISAGREE annunciation only while the conditions existed, but would not remain on the display after the flight.

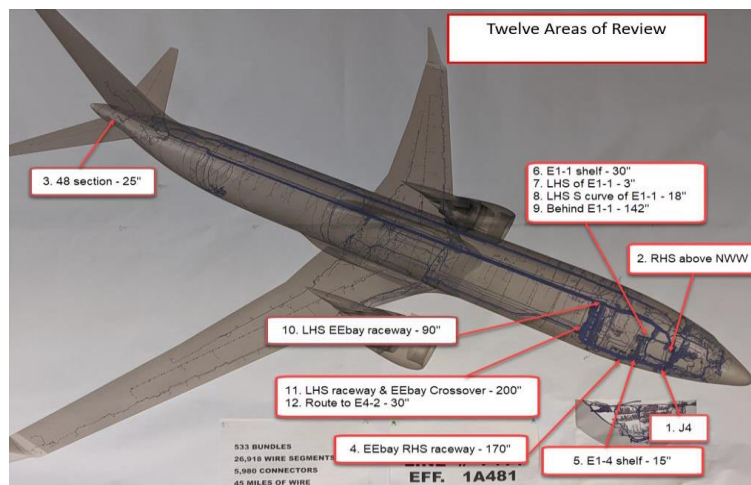
FIGURE 5 737 MAX STABILIZER TRIM MOTOR WIRE SEPARATION

As part of the FAA's review of these design changes, the agency re-reviewed the entirety of the 737 MAX horizontal stabilizer control system. This review revealed that the physical separation of the horizontal stabilizer trim arm wiring and the horizontal stabilizer trim control wiring does not meet the criteria specified in 14 CFR 25.1707. This design standard was promulgated in 2007 and therefore is part of the certification basis of the 737 MAX but not of previous Boeing Model 737 airplanes. Certain wiring installations must have enough physical separation so that a wiring failure cannot create a hazard. (See 14 CFR 25.1707).

Since design changes must comply with FAA regulations, the FAA proposes to require changes to the wiring installation to meet the required physical separation between the horizontal stabilizer trim arm wiring and the horizontal stabilizer trim control wiring. The FAA proposes this action to bring the airplanes into regulatory compliance. The stabilizer trim arm wiring has since been rerouted in 12 areas of the airplane's Electrical Equipment bay and Section 48 to prevent a potential simultaneous short circuit between the stabilizer arm and control wiring and another 28VDC wire. The 737 MAX design change will include physical separation of existing wires and/or routing of new wires to ensure compliance with regulation. (See Figure 5).
