Final Report

On the accident on **1st June 2009**
to the **Airbus A330-203**
registered **F-GZCP**
operated by **Air France**
flight AF 447 Rio de Janeiro - Paris

Bureau d'Enquêtes et d'Analyses
pour la sécurité de l'aviation civile

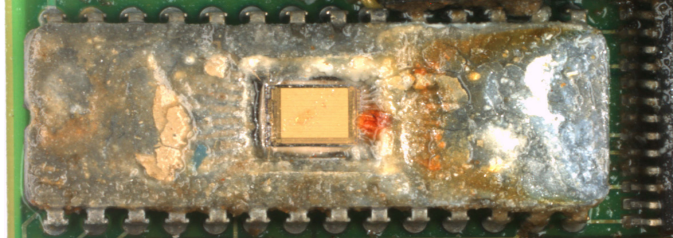
The two computers were examined. The memory components containing the data were damaged. One of the components had been torn out and the other suffered from internal short-circuits. The work was brought to a conclusion.

Figure 30: Memory component from one of the FCDC

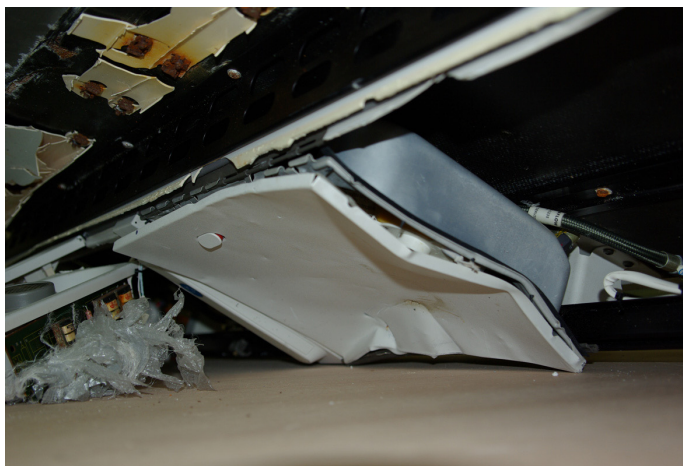
Figure 40: Passenger oxygen container recovered closed:
the deformations on the cover matched those on the box

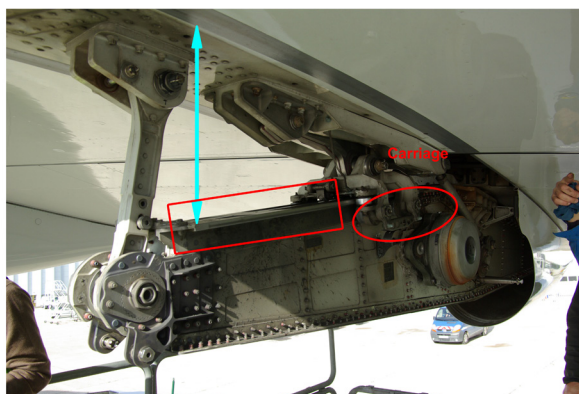
Several parts of the flap extension mechanism fairing were found. There were marks on two of them (positioned at the level of flap track N°3), made by the flap extension track on impact. Analysis of these marks (morphological and dimensional examinations) and comparison with an identical aeroplane made it possible to determine that the flaps were in the “retracted” position (see photo below) at the time of impact with the water (measurement of the distance between the track and the lower surface of the flap, position of the carriage on the track).

Figure 42: Flap extension mechanism (or flap track) No. 3 in retracted position

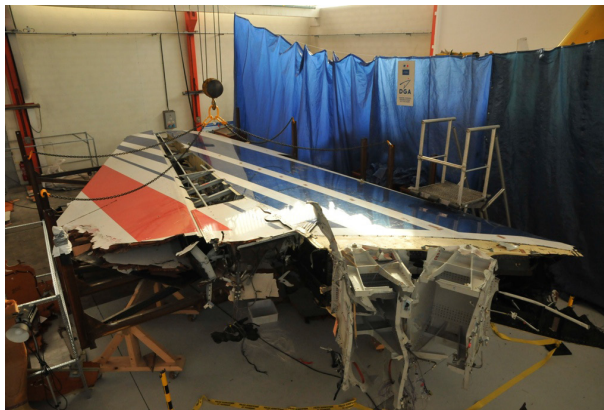
- ❑ The forward attachment (male and female lugs) and the lower part of the side panels (lug reinforcements) were missing;
- ❑ The centre and aft attachments were present: male and female lugs and parts of the fuselage frames.

Figure 44: Fin – In the foreground the base of the fin with the central and forward attachment lugs

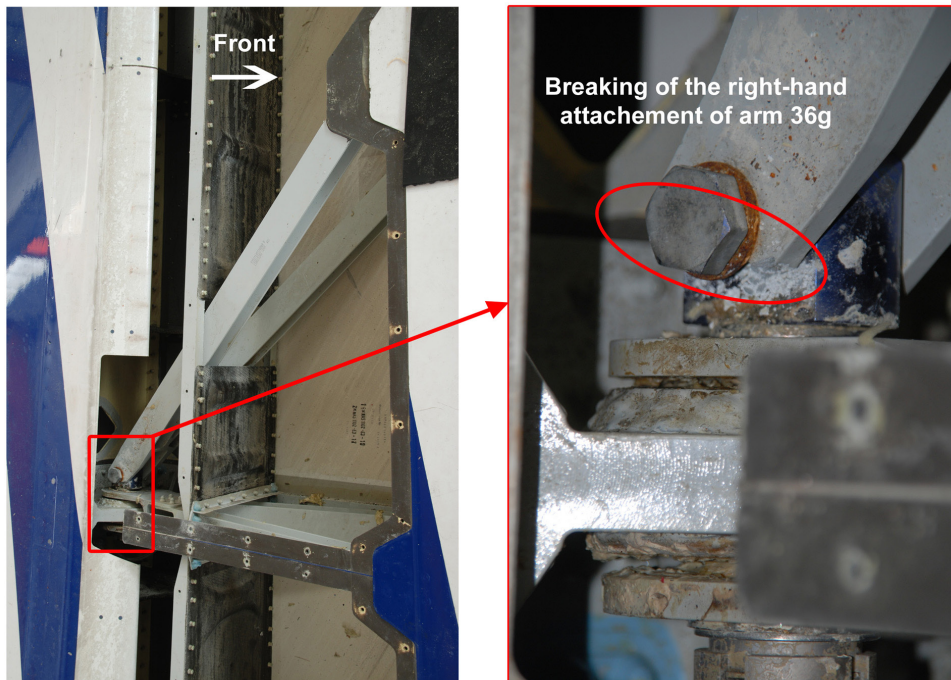
The size of this arm is calculated to withstand a maximum load of 120,000 N, corresponding to a relative acceleration of 36G of the rudder in relation to the vertical stabilizer.

Figure 47: Arm 36G, right view: failure of the rudder attachments

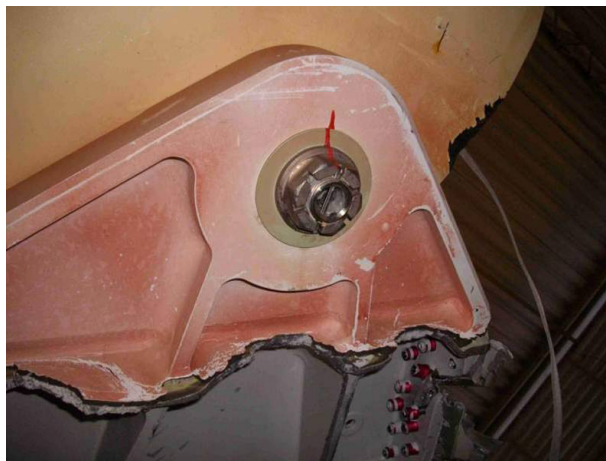
Figure 49: Right-hand aft lug: shearing of the fuselage along main frames 86-87

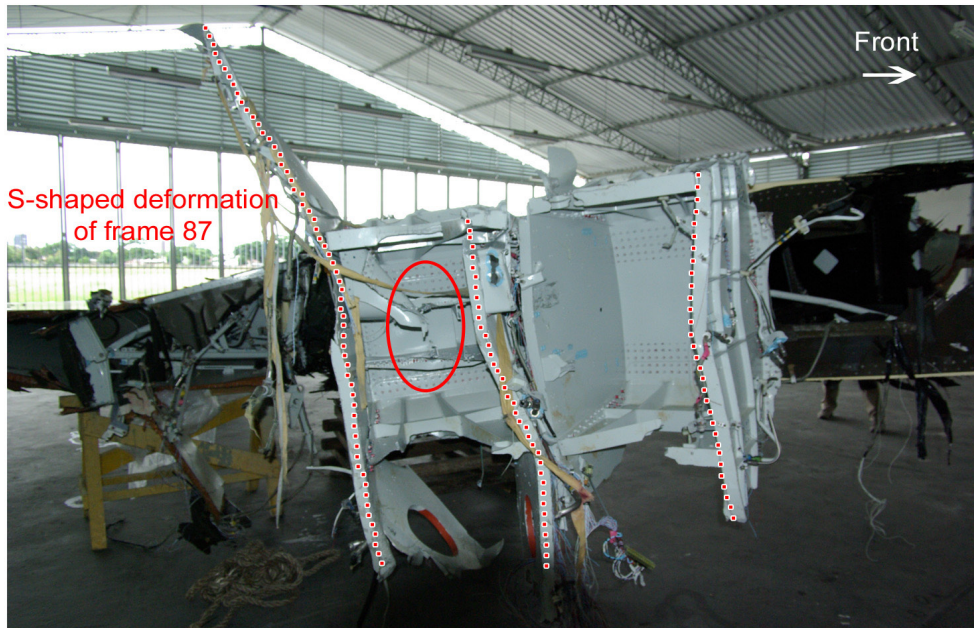
The part of frame 87 that can be seen had undergone S-shaped deformation: the left-hand side forwards, and the right-hand side backwards. The horizontal stabiliser actuator supports were deformed and broke in a backwards movement from the front. These observations indicate a backwards movement of the trimmable horizontal stabiliser.

Figure 50: Frames 84 to 87: S-shaped deformation of frame 87, with frames 84 and 85 pushed in backwards; failure of the horizontal stabiliser actuator supports between frames 86 and 87 (red circle)

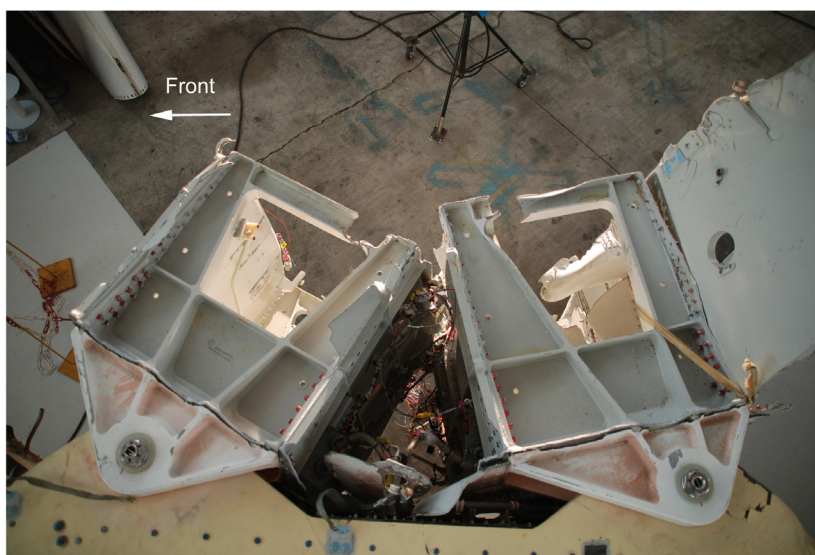
The centre attachment had pivoted backwards with the parts of the frames and web frames that were attached to it. The aft attachment had pivoted forwards with the parts of the frames and web frames that were attached to it.

Figure 51: Fin centre and aft attachments

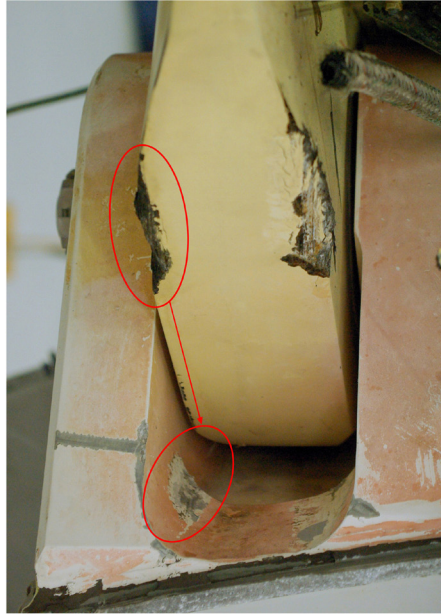
The aft attachment lugs (male on the fin and female on the airframe) had marks indicating a backwards movement of frames 86 and 87 as a whole.

Figure 52: Rear view of the left-hand aft lug: there were marks showing a backwards pivoting of frames 86 and 87

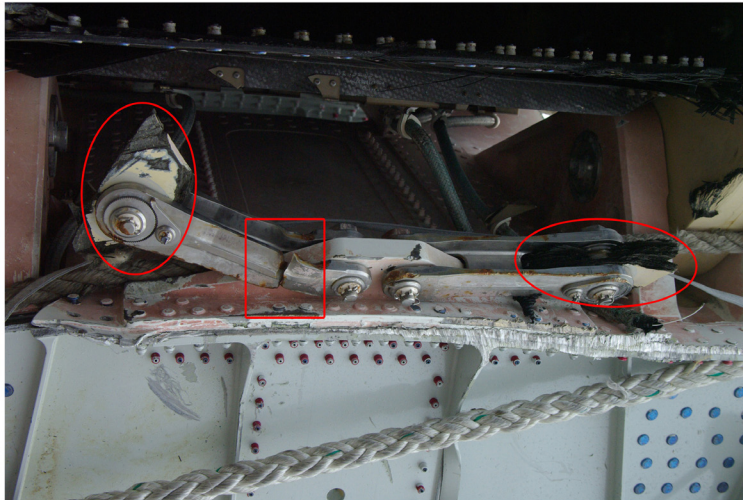
Figure 54: Compression failure of the aft spar at the level of the attachments of the lateral load pick-up rods and failure of the left-hand rod by buckling

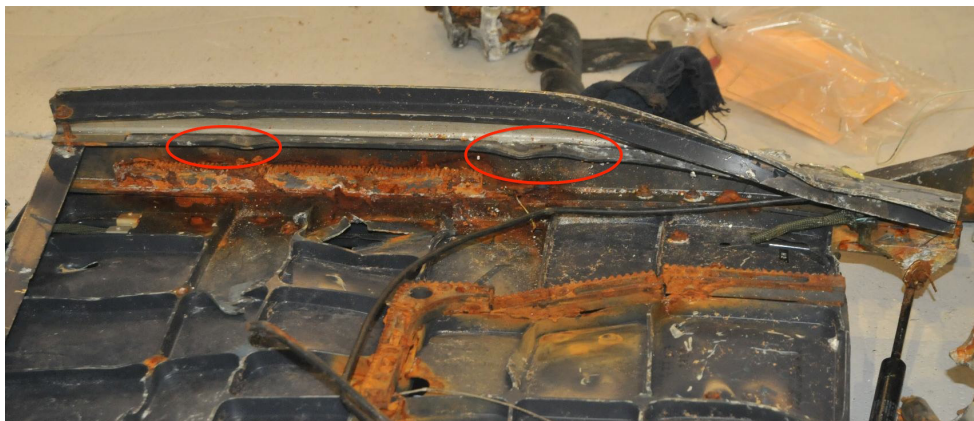
Figure 80: Roller marks on the guidance rail
