Final Report

On the accident on **1st June 2009**
to the **Airbus A330-203**
registered **F-GZCP**
operated by **Air France**
flight AF 447 Rio de Janeiro - Paris

Bureau d'Enquêtes et d'Analyses
pour la sécurité de l'aviation civile

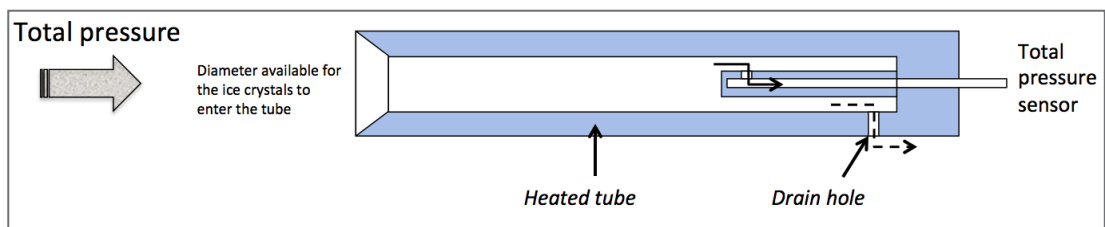
Figure 8: Pitot probe diagram

When highly specific climatic conditions are met, in particular with the presence of ice crystals in excessive quantities, the conditions for use of the probes can exceed the conditions for qualification and robustness. In this type of situation, a partial obstruction of the total pressure probes in icing conditions and at high altitude (above 30,000 feet) can occur. This results in a temporary and reversible deterioration of total pressure measurement.

In the presence of ice crystals, there is no visible accretion of ice or frost on the outside, nor on the nose of the probe, since the crystals bounce off of these surfaces. However, the ice crystals can be ingested by the probe air intake. According to the flight conditions (altitude, temperature, Mach) if the concentration of crystals is greater than the capacity for de-icing of the heating element and evacuation by the purge holes, the crystals accumulate in large numbers in the probe tube.

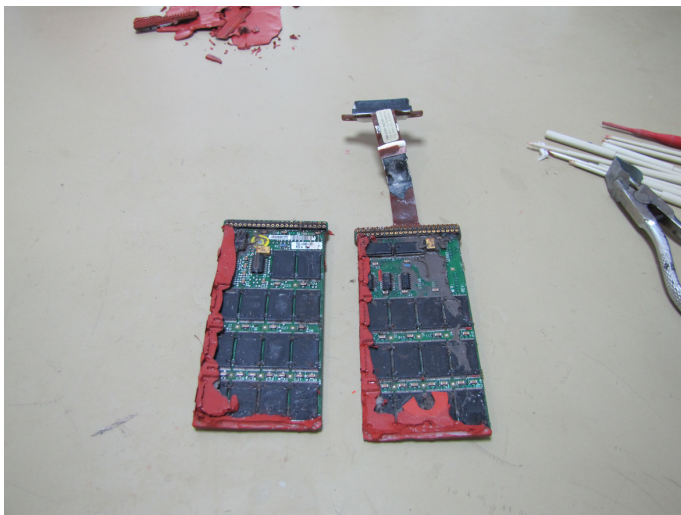
Figure 23: CVR memory boards before cleaning

Visual inspection of the boards revealed damage: a capacitor and a resistor were cracked on one of the boards; two decoder-type components were damaged on the other board.

The boards were placed in an oven for 42 hours. The damaged components were unsoldered and replaced. The impedance value measured at the input connector complied with the measurements made on reference boards. The memory boards were then connected separately to the BEA's memory reader. A few memory components selected previously were addressed and read entirely. The consistency of the binary contents of each memory could then be checked using the manufacturer's hardware and software. The boards were then connected to the BEA's chassis and the data was extracted and decompressed using the manufacturer's official hardware.

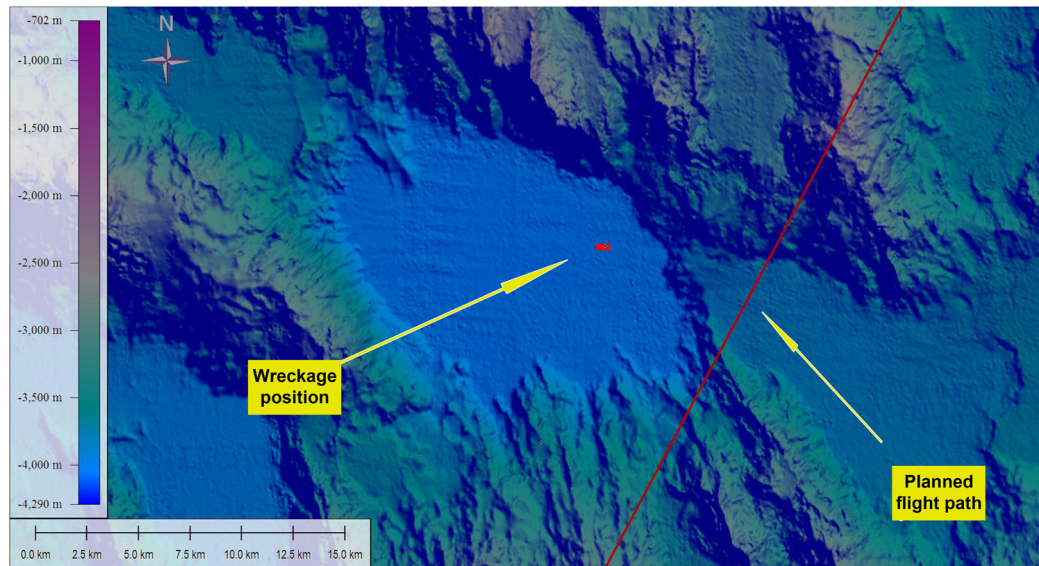
Figure 32: Wreckage localisation

The aeroplane wreckage was found about 6.5 NM on the radial 019 from the last known position, slightly to the left of the planned route. The wreckage rested on an abyssal plain at a depth of 3,900 metres. This plain, surrounded by terrain, made of clay type sediment, was around 15 km wide and was located west of the scheduled aeroplane flight path.

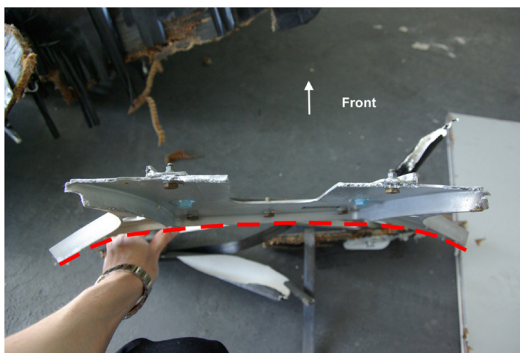
Figure 36: Luggage rack fitting deformed towards the front Toilet door (L54)

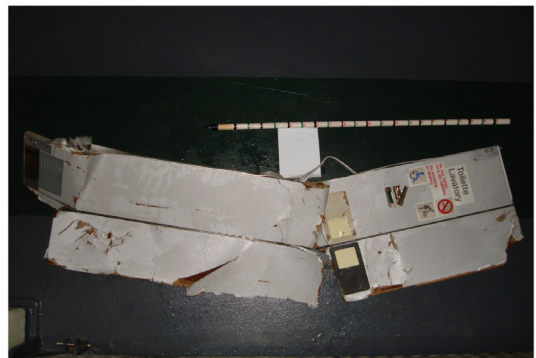
Figure 37: Metallic stiffeners deformed by buckling

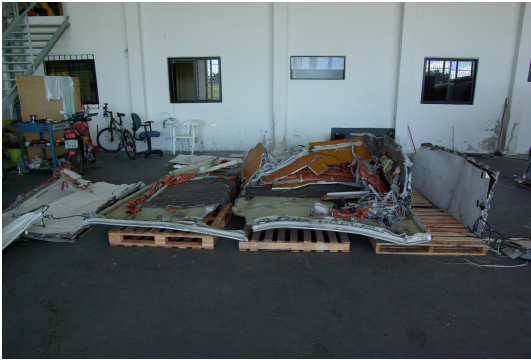
The wall fragments were crumpled. The reconstitution of the ceiling showed it was bent downwards and the floor bent upwards.

These deformations were symmetrical on the left and right sides with respect to the aircraft centreline.

Figure 38: Floor of the LDMCR:
with bottom-upwards deformation

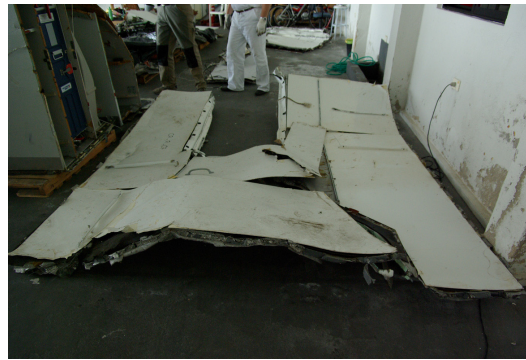
Figure 39: Ceiling of the LDMCR:
with top-downwards deformation

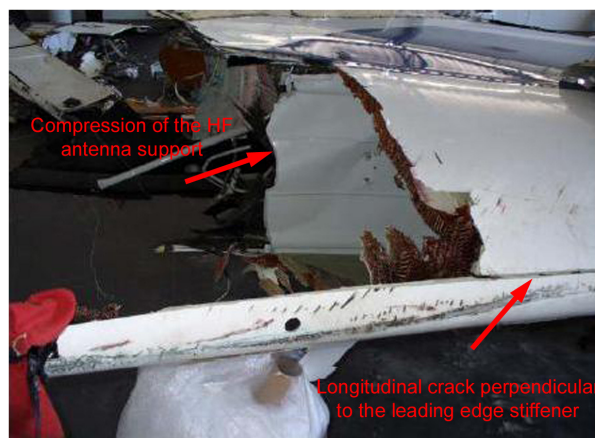
Figure 46: HF antenna support

- ❑ Failure of the leading edge right- and left-hand panels
- ❑ Longitudinal cracking of the leading edge stiffener
- ❑ HF antenna support (attached to the forward spar): failure of the lower part, crumpling indicating bottom-upwards compression loads.

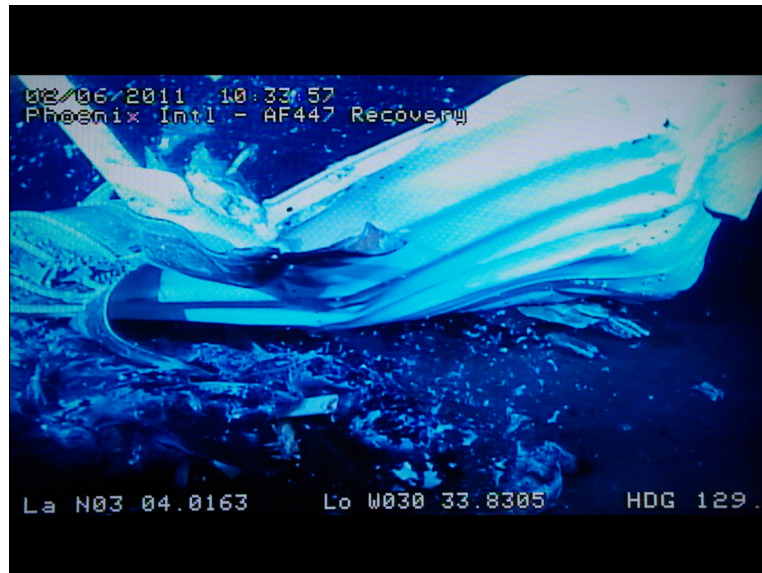
Figure 56: Parts of the fuselage

The lower elements of the fuselage were badly broken up and deformed. In these areas, crushing of the sheet-metal between the ribbing was noted, which indicates a vertical component at the time of impact.

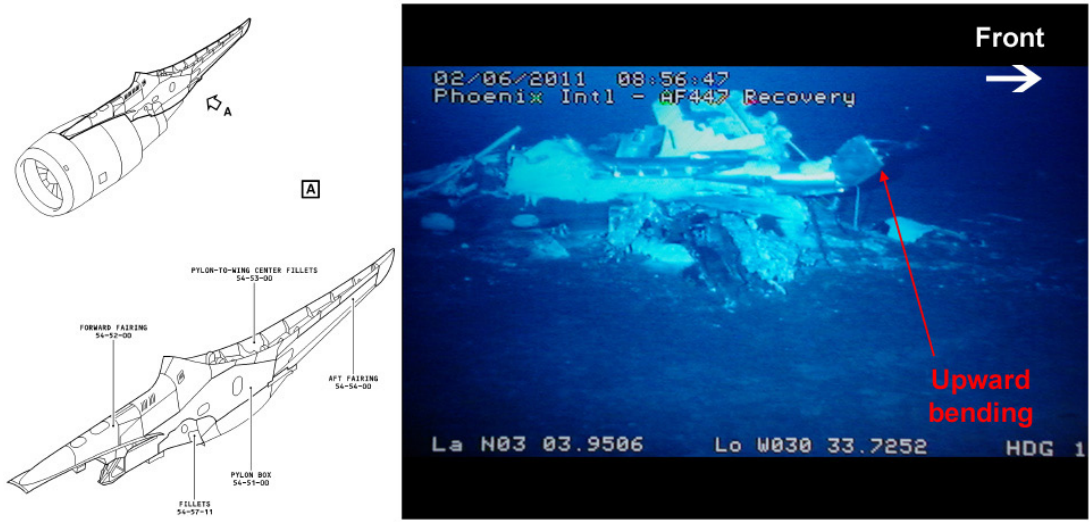
Figure 58: Engine pylon

The engine pylons were found separated from the wings. They had deformations compatible with loads on the engines from below to above.

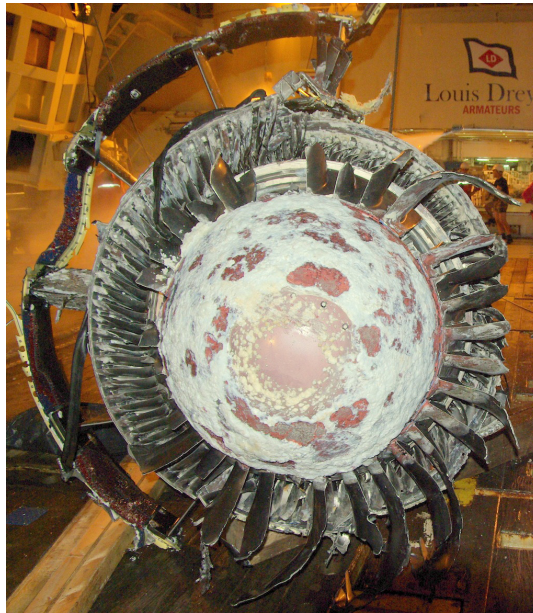
Figure 60: Front view of engine

The visual examination of the two engines showed that they were at high RPM at the moment of impact with the sea.

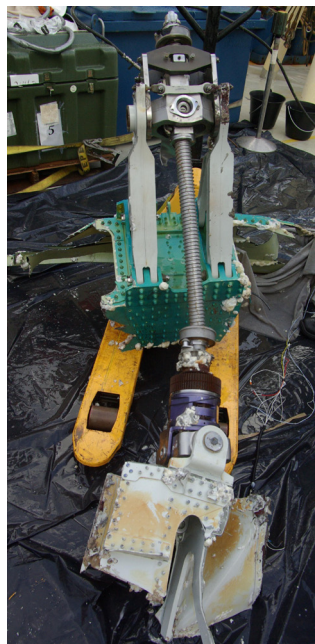
Figure 61: Trimmable horizontal stabiliser screwjack after being raised on board

According to the manufacturer's technical documentation, the relative position of the actuator and the THS screwjack corresponded to a THS position of between 13° and 13.5° nose-up.

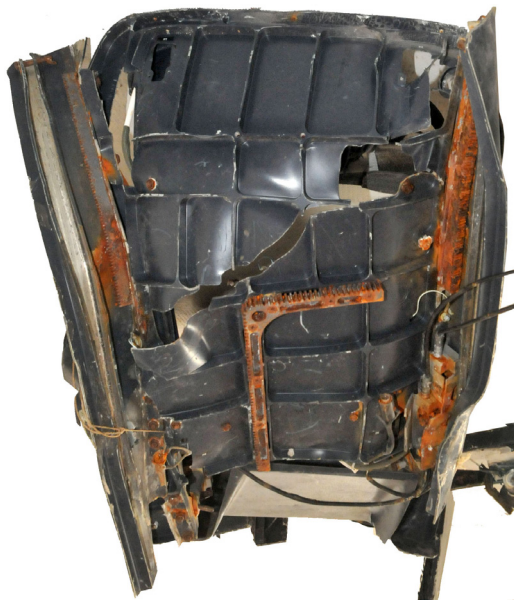
Figure 81: Right side seat cushion

The marks left by the adjustment mechanism under the seat cushion enabled the horizontal position of the seat on impact to be determined. The seat was positioned 5.5 cm from the most forward position.

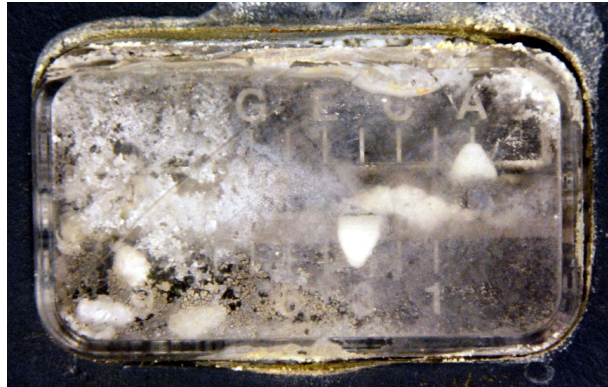
Figure 83: Dial indicating armrest position

The armrest was recovered in the up position, a probable consequence of the impact. The armrest position was indicated on the dial dedicated to this function. The needles were positioned on A values (adjustment from A to K for height) and 3 (adjustment from 1 to 9 for tilt angle). The armrest cladding was dismantled in order to check mechanism integrity and validate the needle positions. The mechanisms were demonstrated to be irreversible during certification tests, that is to say that leaning on the armrest did not modify the adjustments made with the knobs.

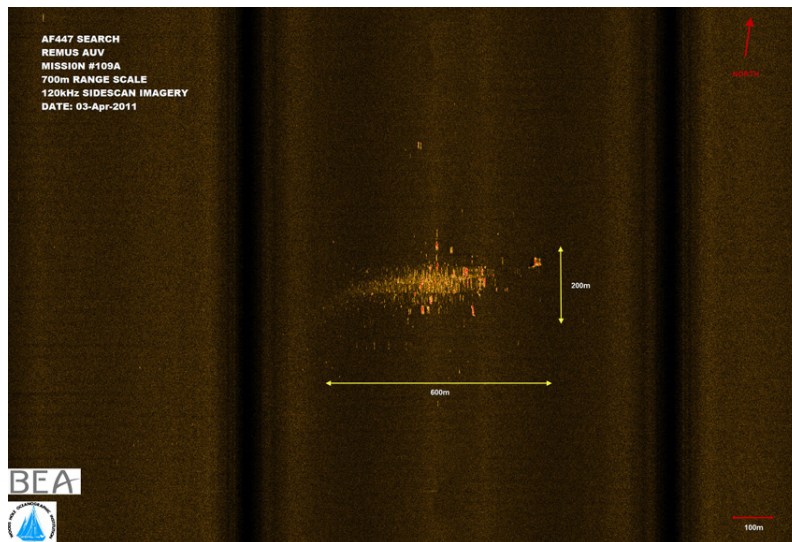
Figure 92: General view using sonar imaging: 120 kHz, range of 700 m

The wreckage was discovered on 2 April 2011 with the aid of the REMUS AUV's side scan sonar adjusted to a frequency of 120 kHz and a 700-metre range.

The first passage brought to light a concentration of backscattered data over an area of around 600 metres by 200 metres.

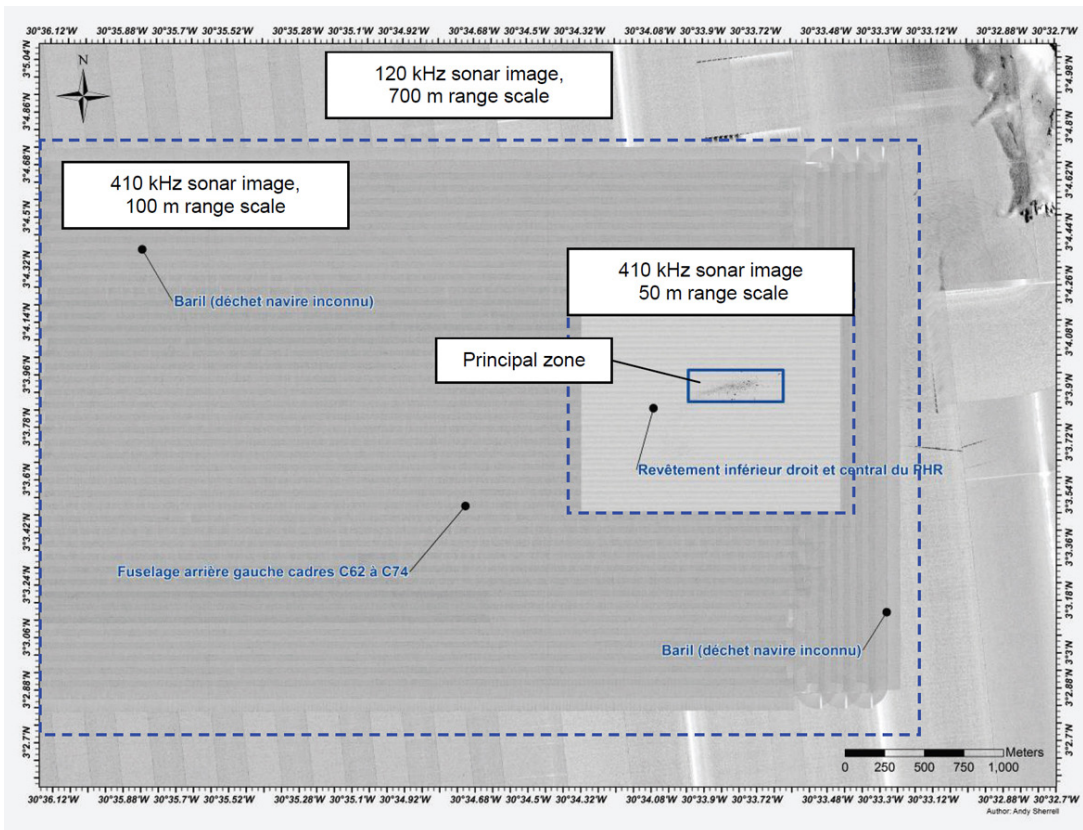
During phase 4, the area was scoured several times by the REMUS AUVs with different sonar settings to make sure that no possible debris, located beyond the main zone, was forgotten. This exploration made it possible to localize a part of the fuselage about two kilometres from this zone as well as objects such as oil drums that did not come from the aircraft (see the following figure). The initial imagery was subsequently enhanced by high resolution 410 kHz sonar images at various range scales.

Figure 97: Overlay of sonar images taken with various settings:
120 kHz, 700 m range scale - 410 kHz, 100 m range scale - 410 kHz, 50 m range scale

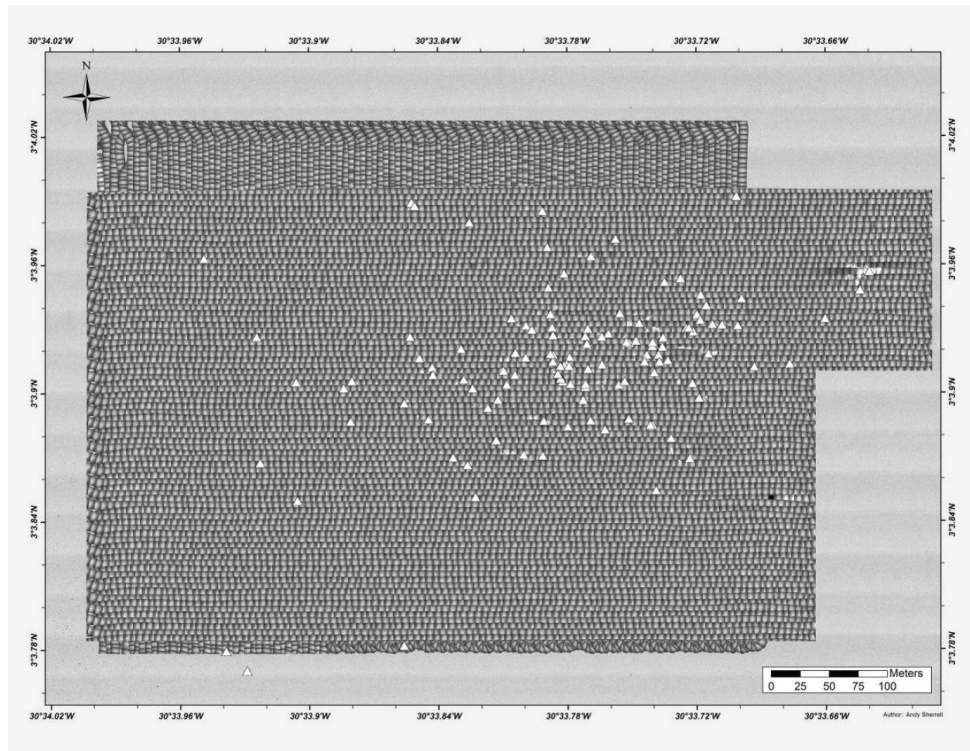
Figure 98: Visualisation of the photo mosaic obtained with REMUS AUV images and the aeroplane debris identified by using the REMORA ROV
